# EFFICACY OF RED AND YELLOW TURN ARROWS IN TRAFFIC SIGNALS

**November 1975**  
**Final Report**

**Prepared for**  
**FEDERAL HIGHWAY ADMINISTRATION**  
**Offices of Research & Development**  
**Washington, D. C. 20590**

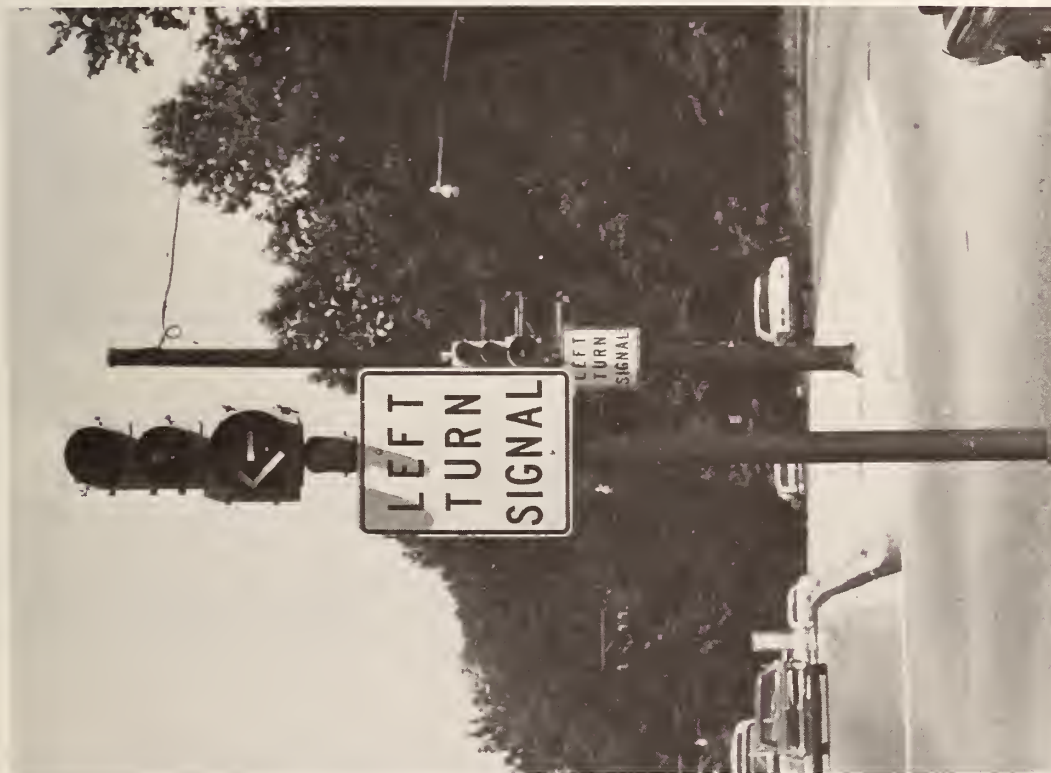
The signal in the "before" condition.

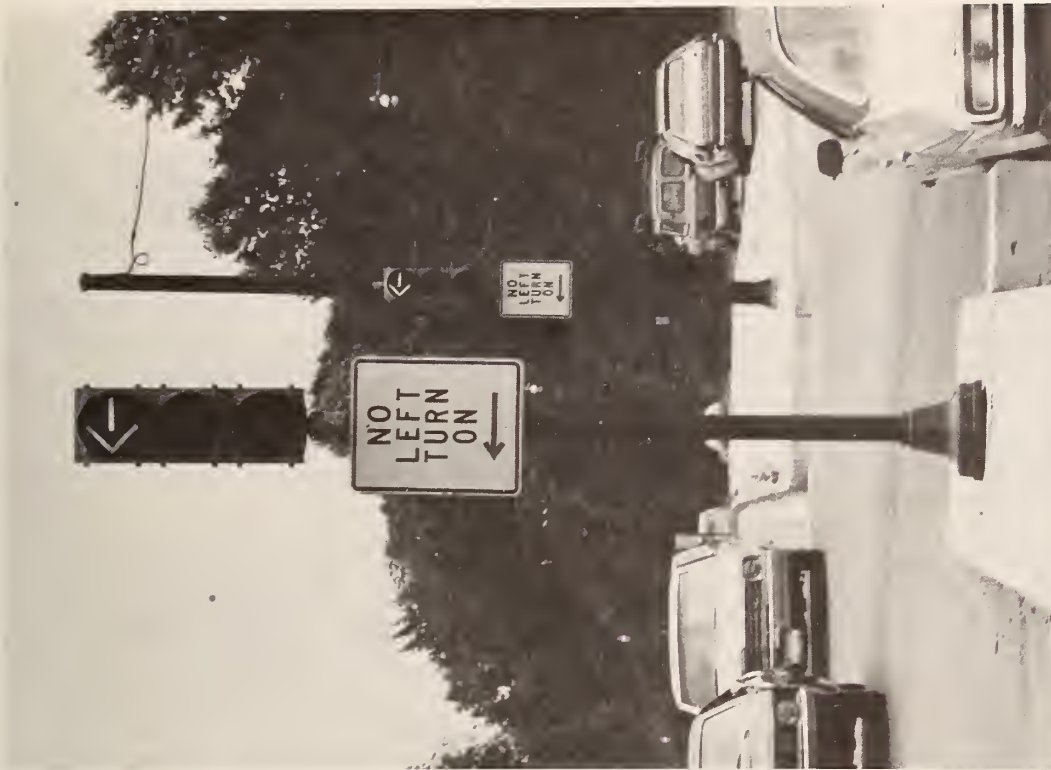
Figure 33 ( continued )

The signal in the "after" condition.

In the "after" condition "No Left Turn on (red arrow symbol)" signs were mounted immediately below both the near and far side median mounted left turn signals. These signs may be seen in several of the views of the location presented in Figure 33.

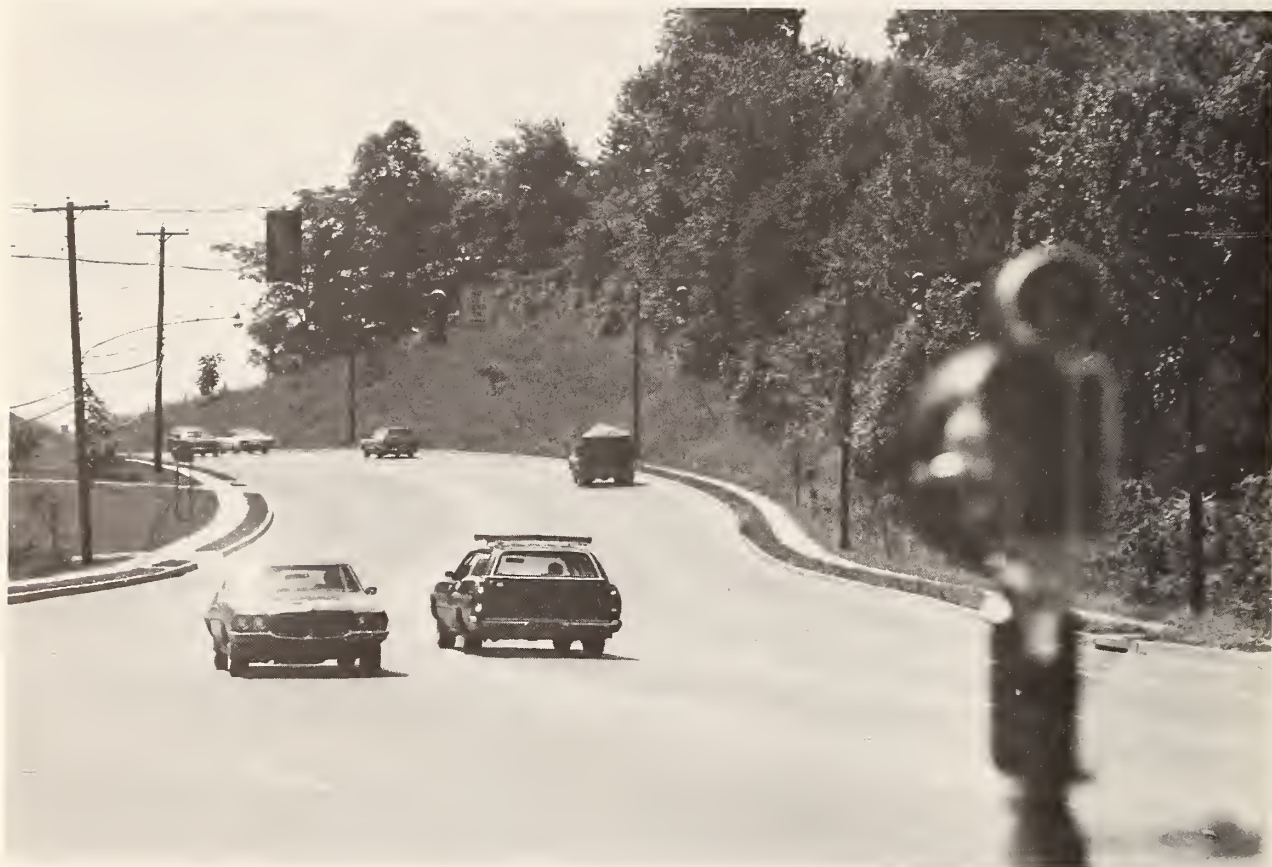
Figure 35

Views of the westbound approach of Montrose Road to Tildenwood Drive (location 23)

The study site was the intersection of Montrose Road with Tildenwood Drive. This intersection was approximately 3/4 mile west of the other suburban site. At this location Montrose Road had two lanes for through traffic in each direction, and a painted median which narrowed on the east side of the intersection to provide an exclusive turning lane for the westbound to southbound left turn. This left turn was the movement of interest. The location is shown in Figure 35. The site was assigned location reference number 23 for film scoring and data analysis purposes.

Traffic through this intersection was controlled by span-wire mounted signals operated by a fully actuated controller. The signal operation was three phase with: (a) Montrose westbound through traffic and the westbound to southbound left turn flowing, while eastbound Montrose was stopped and right turns by northbound Tildenwood's vehicles were permitted; (b) through traffic on Montrose flowing in both directions, while the lefts from westbound Montrose and all movements from northbound Tildenwood were prohibited; and (c) lefts and rights from northbound Tildenwood moving while all traffic on Montrose was stopped. The signal controller had the capability to skip any uncalled phase.

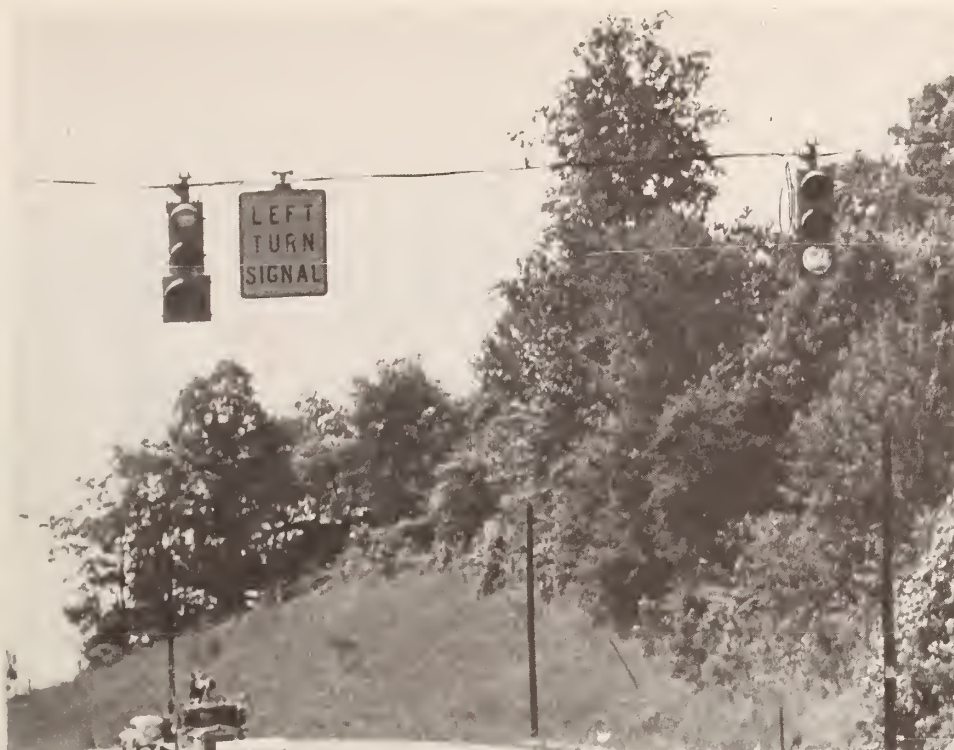
The signals in the "before" condition.

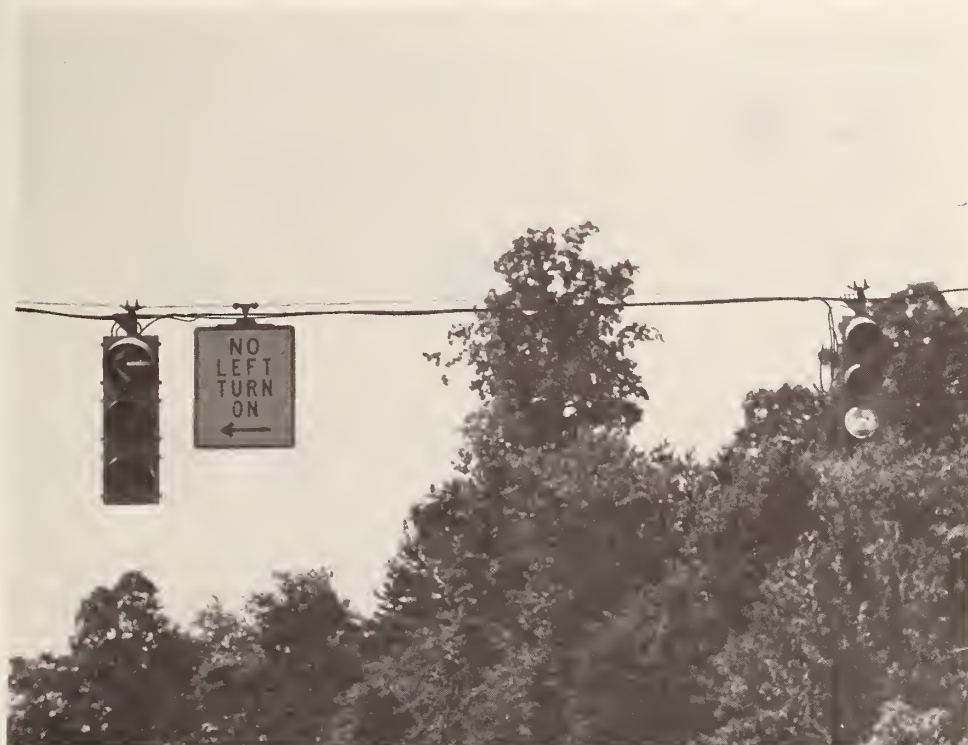
Figure 35 ( continued )

The signals in the "after" condition.

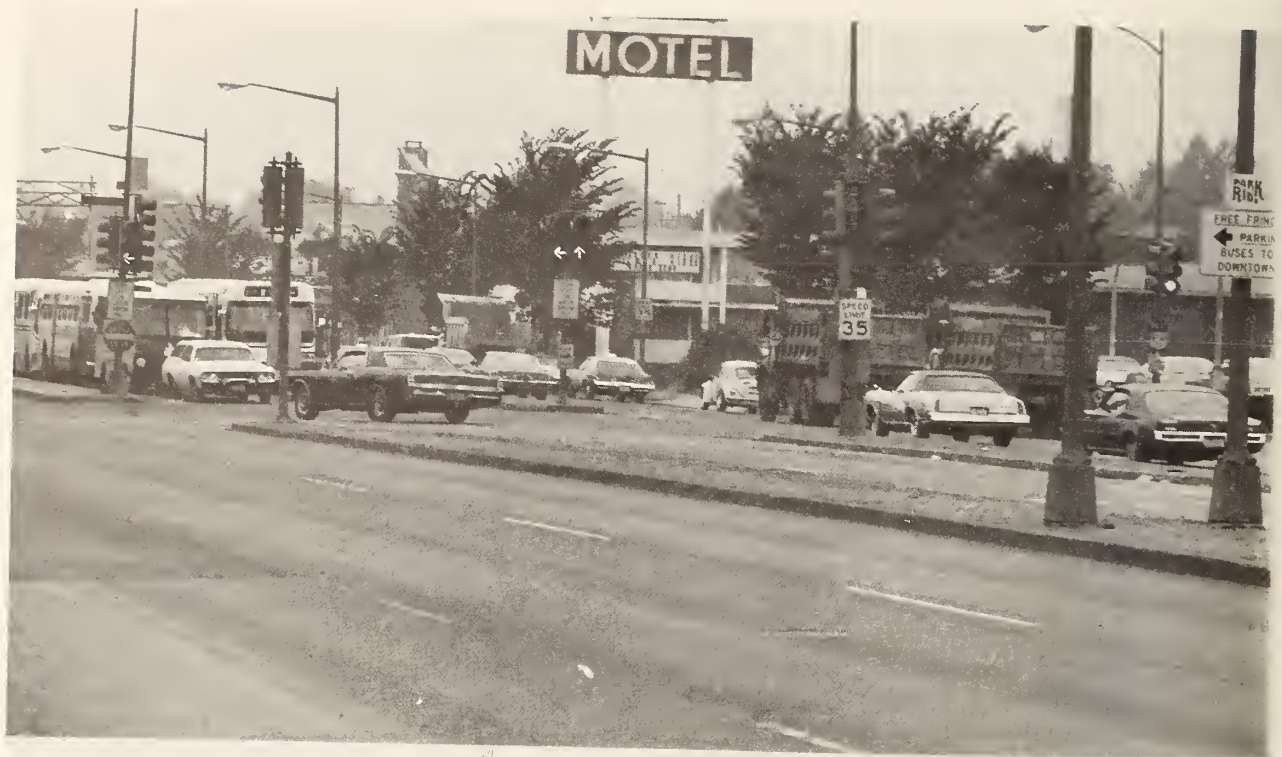
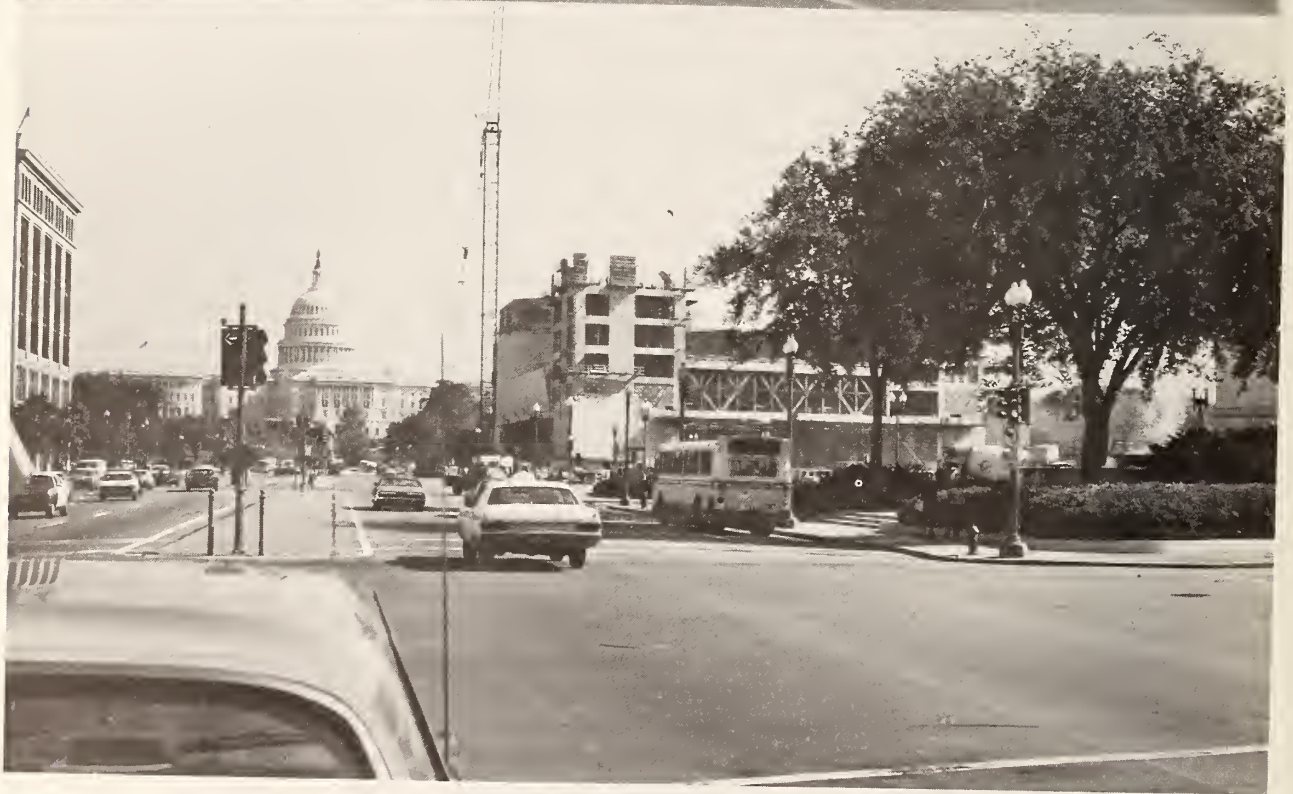
Figure 38

Intersections using green ball displays on right side of through approach, and green through arrows on left side of through approach, with turn arrows to control left turn lanes.

When left turns from an approach are prohibited during part of the signal cycle, and a through green arrow indication is shown to that approach ( with or without a red left arrow ) , significant problems can occur in handling the right turns from that approach and the pedestrian movements in the crosswalk on that approach's right. To carry the previous example further, if north and southbound movements have green through arrows, then provision must be made for both the southbound to westbound right turn, and the north-south pedestrian movement in the west crosswalk. One way to handle this is to go to an exclusive pedestrian phase. This would prohibit pedestrian movement north-south while the northbound and southbound vehicles were moving, and would give a right turn free of conflicts with legal pedestrian movements. Such a signal operation is likely to increase pedestrian delays, and to also reduce the proportion of the signal cycle available for vehicular movements. A second approach would be to make an additional split in the phasing and to have both: (a) an interval for north-south pedestrian movements while the right turn was prohibited; and (b) an interval for the right turn while pedestrians were prohibited from being in the crosswalk. In view of pedestrian crossing time requirements for wide streets this could lead to long signal cycle lengths, as well as to increased delays to both pedestrians and right turning vehicles. A third approach would be to simply prohibit either the right turn, or the pedestrian movement in the west crosswalk. At several locations in this study where the approach was multi-lane a fourth approach to dealing with the problem of handling right turns and pedestrians at a location with a through arrow was tried, and found successful. This approach involved using: (a) a through green arrow plus red left arrow display on the left side of the approach to show the left turn prohibition; and (b) a green ball display on the far right corner of the intersection to show that both through and right turn movements were permitted, but that the right turn was not protected from a pedestrian conflict ( that the right turn was burdened by the normal right-of-way rule that turning vehicles must yield to pedestrians ). Installations with median mounted through arrows and right side mounted green ball displays were used very successfully in this study at both the New York and Bladensburg, and the Pennsylvania at 6th experimental sites. These installations are shown in Figure 38. Yet a fifth possible approach to preventing a left turn without creating problems for right crosswalk pedestrians and the right turn would be to use a green ball plus red left arrow display. This display is prohibited by Section 4B - 6 ( 5.e. ) of the MUTCD ( page 220 ). However, such a display was tested in the Questionnaire used in the

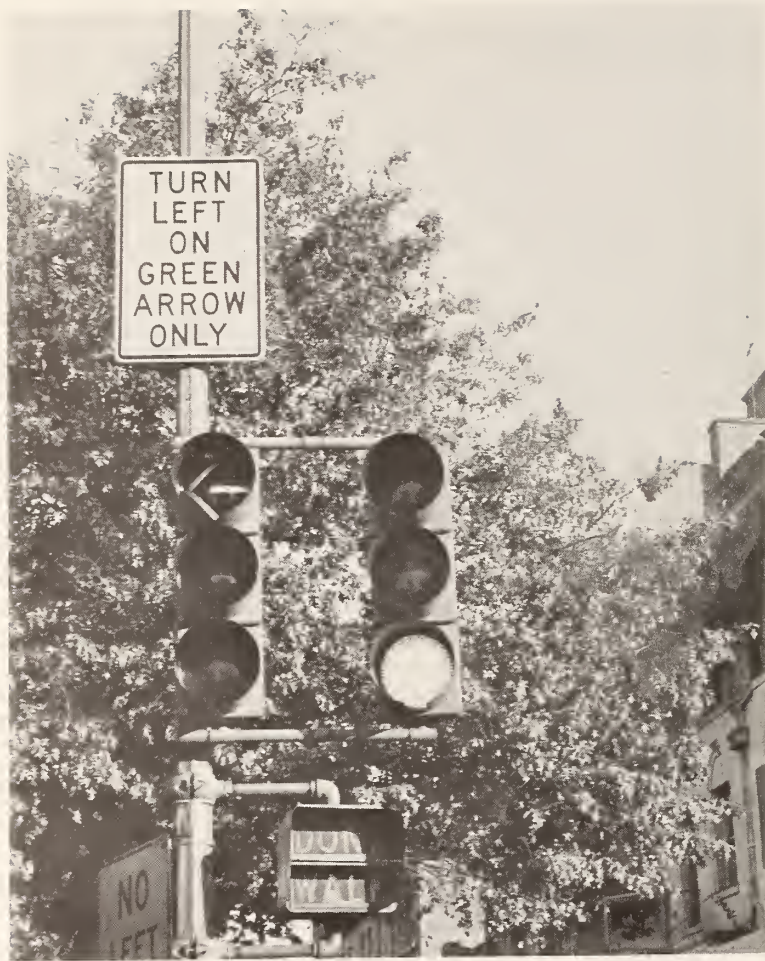
Figure 39

How a red left turn arrow plus green circular ( ball ) lens signal display would look. The signal assembly comprises a signal head with red, yellow and green left turn arrows to control the left turn, horizontally separated from a head with conventional circular lenses to control through and right turn movements.

The visibility from a distance of an arrow display is less than that of an equal size circular ( ball ) lens illuminated by the same lamp, and yellow arrows have significantly better visibility from a distance than do red or green arrows. This is the reason for the MUTCD requirement ( Section 4B - 8 ( 5 ) ) for using 12 inch lenses with all arrow displays. Shifting from eight ( 8 ) inch ball displays to 12 inch arrow displays for the turn signals increases the

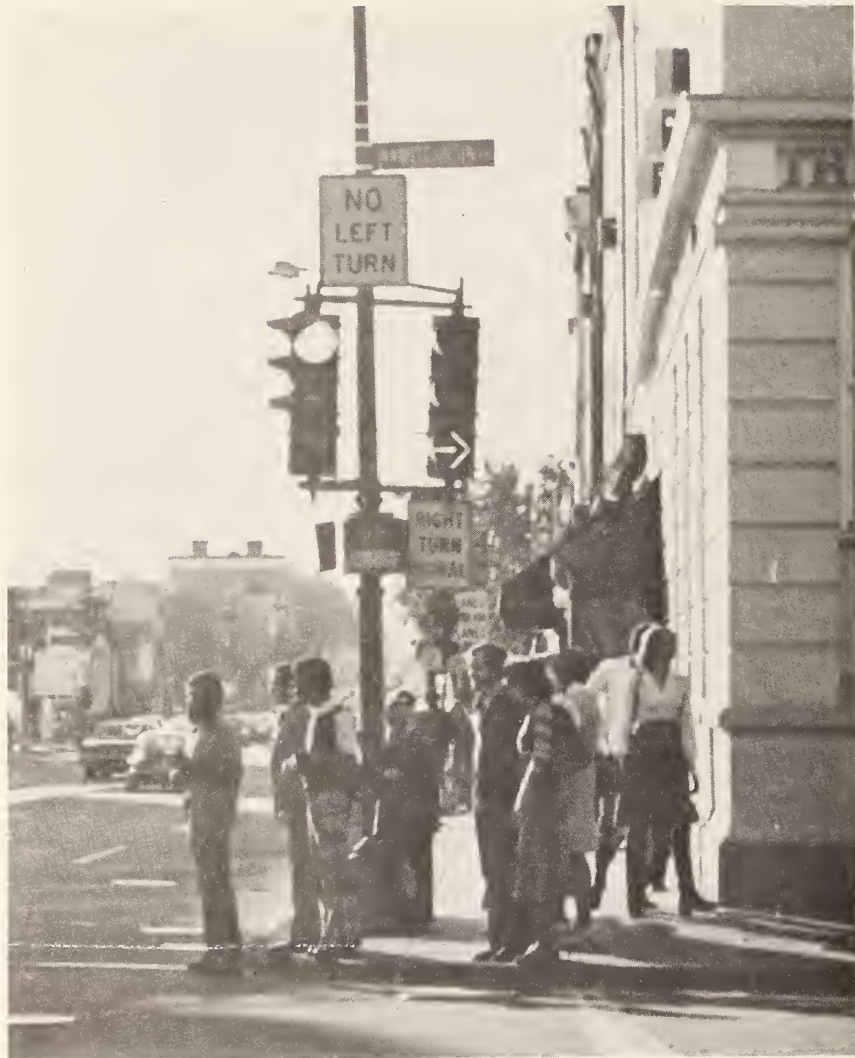
Figure 40

Horizontal separation of the turn signal head from the head with the indications for through traffic.

At locations where traffic is halted on one approach before it is halted on the opposite approach ( locations with a "lagging green" ) there is a potential for an accident hazard to vehicles turning left. The hazard results from the tendency of drivers waiting to turn left from the approach whose movement is shut off first, to try to make left turns at the end of their movement in the mistaken belief that opposing traffic is also being stopped. The driver waiting to turn left and seeing his movements clearance interval display may, naturally but incorrectly, decide that the opposing flow is also being stopped and try to make the turn,

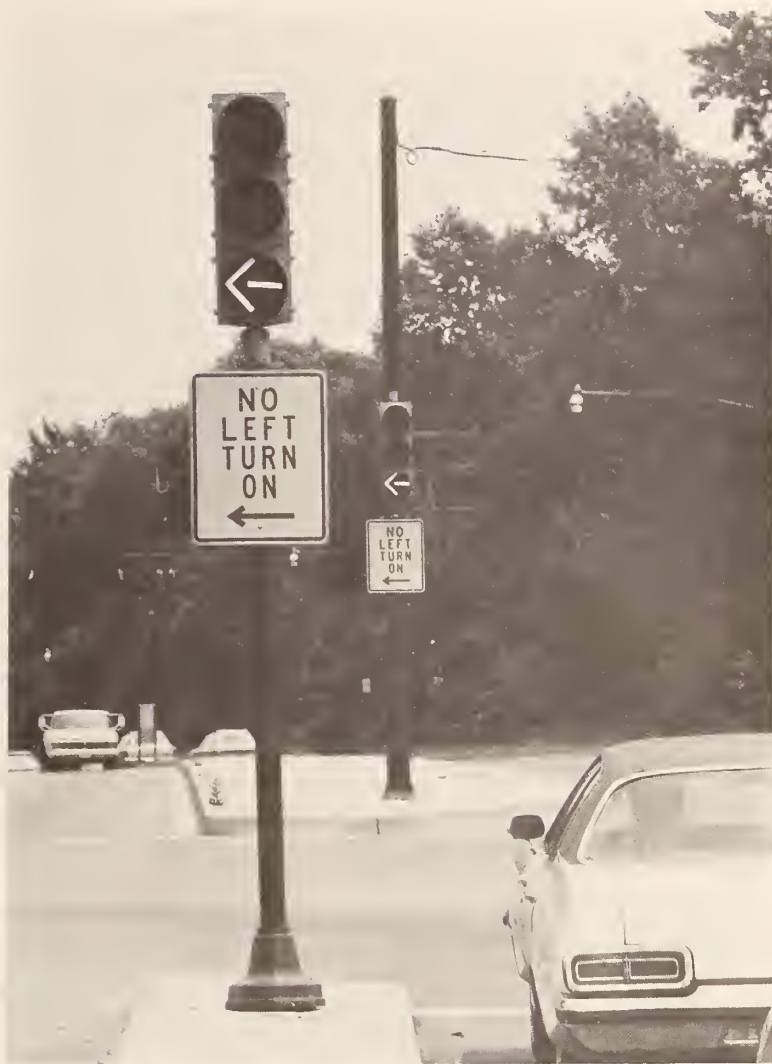
Figure 41

Black and white photograph of sign using symbolic colored arrow showing loss of meaning of such a sign when color is lost. Such loss of color is typical when colors "fade down" to black under low levels of illumination at night.

It is strongly recommended that all arrow turn signal displays be provided with explanatory signing. In signing turn arrows it is recommended that word messages, rather than mixed word and symbolic messages be used. It was found at night that under low levels of illumination the color red tends to "fade down" to black and make a symbolic red arrow appear to be a black arrow. The same effect appears, to a somewhat different extent, with symbolic green arrows. These effects can destroy the meaning of signs using symbolic arrows to explain the meaning of turn arrows in signals. The effect can be seen in Figure 41, a black and white photograph of a "No Left Turn On ( symbolic red arrow )" sign. Note that, with the color gone, the sign appears to read "No left Turn On Arrow". While the effect is not acute, it does appear to make use of word message signing ( e.g. "Right Turn On Green Arrow Only" superior to mixed word and symbol signing.
